Polishing Porcelain

A Note on New Rotary Abrasive Tools

C.F. Valcke

Recently developed rotary abrasive tools for polishing ground dental porcelain are discussed. The efficacy of the tools was assessed by scanning electron microscopy and by surface roughness measuring.

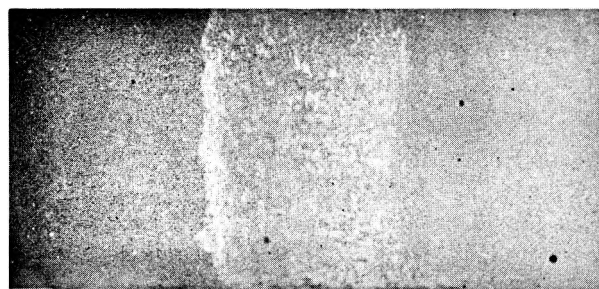
Fig. 1. Surface of porcelain specimen (2 cm x 1 cm).
Left - glazed area
Centre - ground area
Right - polished area (note porosity).

of the porcelain was then ground over two-thirds of its area, using a coarse cylindrical abrasive point and subsequently half of the ground area was polished with the abrasive wheels. Thus the prepared specimen had a surface showing, at one end, the original glaze, at the other end, the polished area, and, in the centre, a ground area (fig 1). The surface of the specimen was then examined with a Taylor-Hobson Talysurf Model 3 surface roughness measuring machine which makes it possible to make a quantitative assessment of the surface roughness.

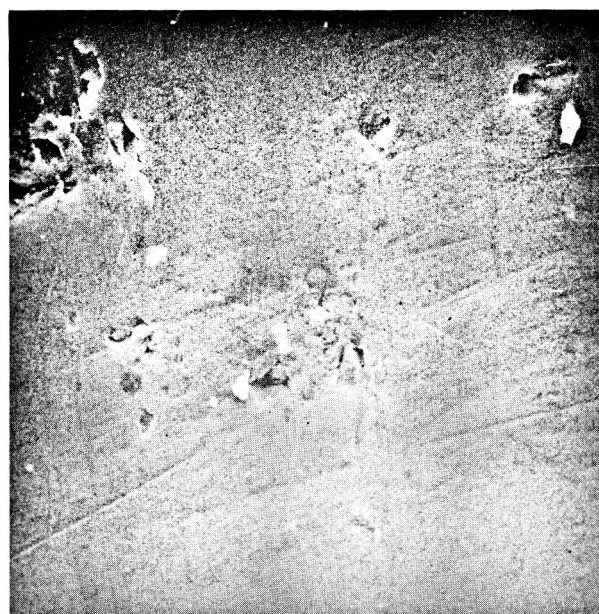
Fig. 2. Electron micrograph, polished commercial denture tooth, showing porosity. Area shown 100 x 100 micrometres.

Scanning electron micrographs of the ground and polished teeth showed a smooth surface with a few linear scratches and occasional defects due to porosity of the porcelain (fig 2). These micrographs were considered relatively uninformative. On the other hand the porcelain specimen which was examined with the surface roughness measuring machine showed that no appreciable surface defects were evident in either the glazed or polished areas (figs 3 and 5). In contrast to this the trace of the central (ground) area showed marked surface irregularities, some were of the order of four micrometres (fig 4). In figs 3, 4 and 5 the horizontal magnification is 100 x and the vertical magnification 1000 x. The distance between the straight horizontal lines therefore represents two micrometres.

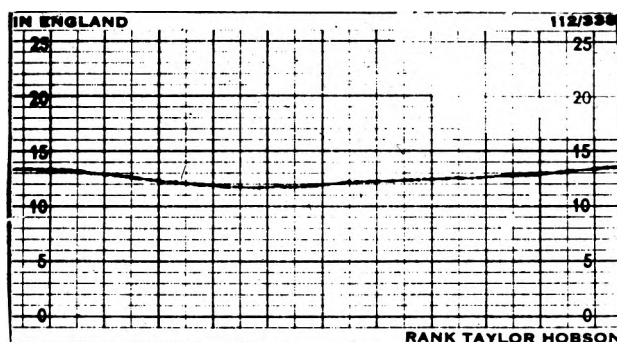
Fig. 3. Trace of glazed area in fig 1 produced by surface roughness measuring machine.

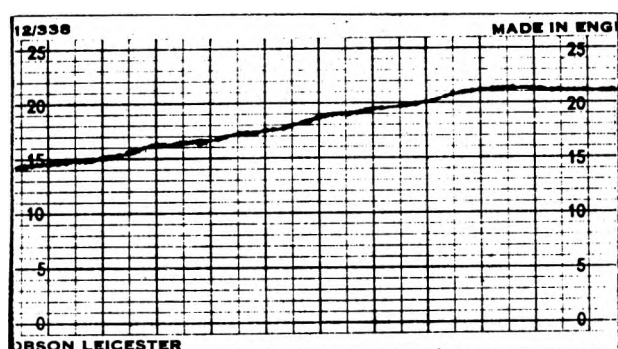
Fig. 5. Trace of polished area in fig 1 produced by surface roughness measuring machine.

and breadth of surface irregularities, but not their depth. It is for this reason that the scanning electron micrographs were considered relatively uninformative. In contrast to this the machine used for surface roughness measuring of the specimen demonstrated the depth of the irregularities in the ground area and showed that the finish in the polished area was comparable to the original glaze.
